**Flood Control Project Maintenance  
Levee Inspections**

**Fall 2010 Levee Maintenance Deficiency Summary Report**

**Sacramento River Basin**

**Marysville Levee Commission**

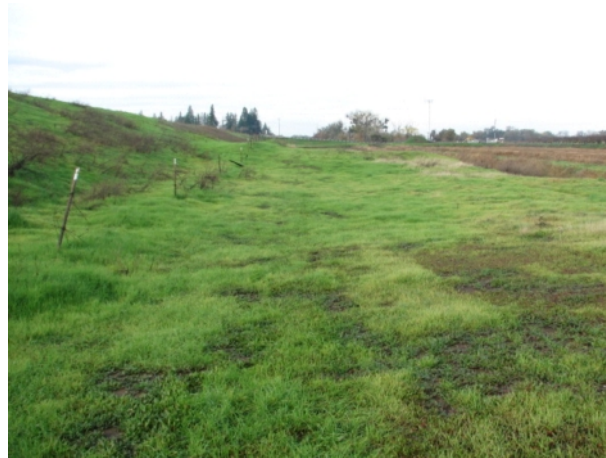
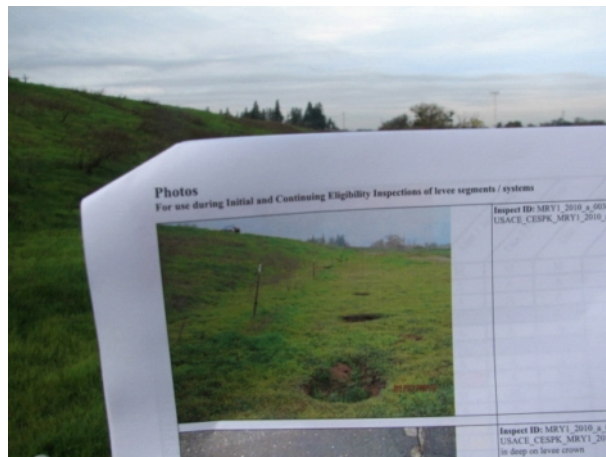
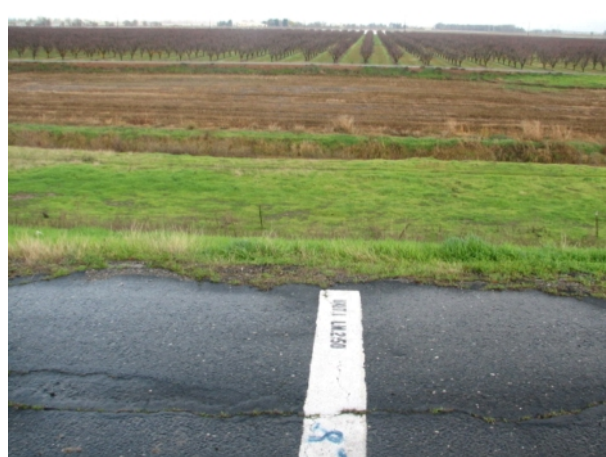
Levee Mile Report Line	1
Start Levee Mile	2.50
End Levee Mile	2.50
Location	Land Side
Category	Earthen Levee
Item	Crown Surface / Depressions / Rutting
This item was identified with an Unacceptable rating in the USACE PI report for the City of Marysville 1 Levee System (MRY1_2010_a_0036). Reinspect on 12/9/10 verifies that repairs were made as indicated in the 11/22/10 letter from the City.	
cathom_f_20101209_166.jpg

Levee Mile Report Line	1
Start Levee Mile	2.50
End Levee Mile	2.50
Location	Land Side
Category	Earthen Levee
Item	Crown Surface / Depressions / Rutting
This item was identified with an Unacceptable rating in the USACE PI report for the City of Marysville 1 Levee System (MRY1_2010_a_0036). Reinspect on 12/9/10 verifies that repairs were made as indicated in the 11/22/10 letter from the City.	
cathom_f_20101209_167.jpg

Levee Mile Report Line	1
Start Levee Mile	2.50
End Levee Mile	2.50
Location	Land Side
Category	Earthen Levee
Item	Crown Surface / Depressions / Rutting
This item was identified with an Unacceptable rating in the USACE PI report for the City of Marysville 1 Levee System (MRY1_2010_a_0036). Reinspect on 12/9/10 verifies that repairs were made as indicated in the 11/22/10 letter from the City.	
cathom_f_20101209_168.jpg

LMR No.	Levee Mile		Category	Item	* Location	** Rating	Action/Comment	GPS Latitude/Longitude		Issue No.
	Start	End						Start	End	Photo
1	2.50	2.50	Earthen Levee	Crown Surface / Depressions / Rutting	LS	A	Inspector Comments: This item was identified with an Unacceptable rating in the USACE PI report for the City of Marysville 1 Levee System (MRY1_2010_a_0036). Reinspection on 12/9/10 verifies that repairs were made as indicated in the 11/22/10 letter from the City.	39.164965 ° -121.572142 °	39.164965 ° -121.572142 °	4 Y
2	3.19	3.19	Earthen Levee	Cracking	CR	A	Inspector Comments: This item was identified with an Unacceptable rating in the USACE PI report for the City of Marysville 1 Levee System (MRY1_2010_a_0028). Reinspection on 12/9/10 verifies that repairs were made as indicated in the 11/22/10 letter from the City.	39.163941 ° -121.560452 °	39.163941 ° -121.560452 °	5 Y
3	3.23	3.23	Earthen Levee	Vegetation	LS	A	Control annual grass and weeds on the levee slopes and easements.	39.163589 ° -121.559494 °	39.163589 ° -121.559494 °	1 Y

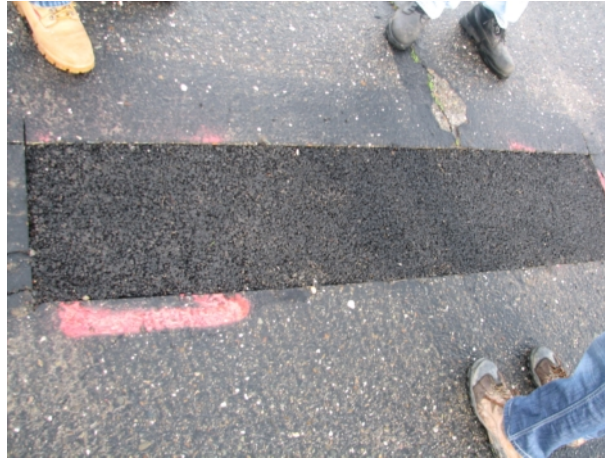
cathom\_f\_20101209\_169.jpg

Levee Mile Report Line	2
Start Levee Mile	3.19
End Levee Mile	3.19
Location	Crown
Category	Earthen Levee
Item	Cracking

This item was identified with an Unacceptable rating in the USACE PI report for the City of Marysville 1 Levee System (MRY1\_2010\_a\_0028). Reinspect on 12/9/10 verifies that repairs were made as indicated in the 11/22/10 letter from the City.

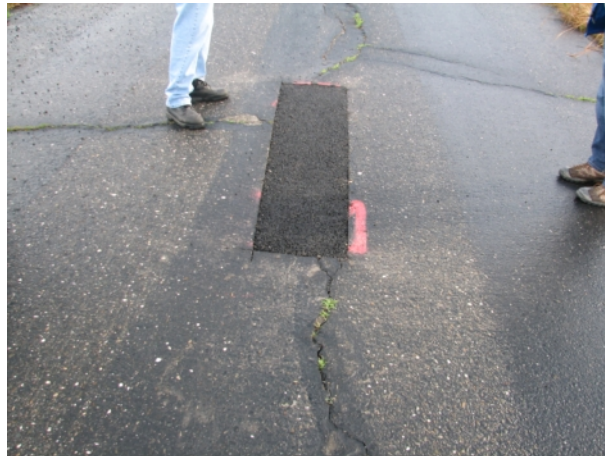
cathom\_f\_20101209\_170.jpg

Levee Mile Report Line	2
Start Levee Mile	3.19
End Levee Mile	3.19
Location	Crown
Category	Earthen Levee
Item	Cracking

This item was identified with an Unacceptable rating in the USACE PI report for the City of Marysville 1 Levee System (MRY1\_2010\_a\_0028). Reinspect on 12/9/10 verifies that repairs were made as indicated in the 11/22/10 letter from the City.

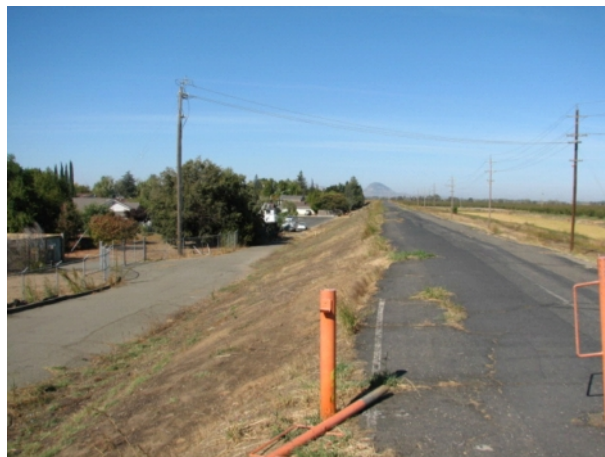
cathom\_f\_20101019\_160.jpg

Levee Mile Report Line	3
Start Levee Mile	3.23
End Levee Mile	3.23
Location	Land Side
Category	Earthen Levee
Item	Vegetation

Levee mile 3.23, land side vegetation, looking up stream.

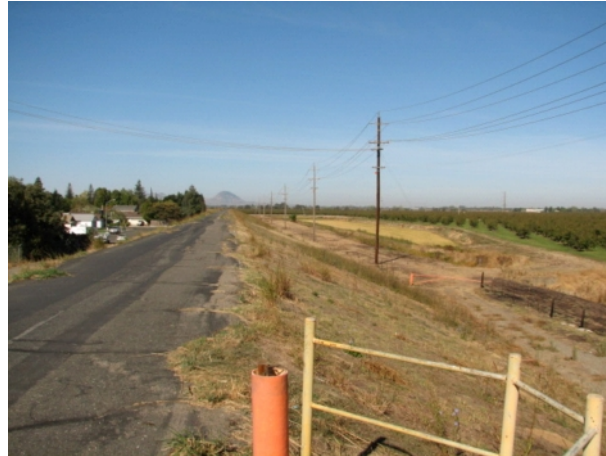
Levee Mile Report Line	4
Start Levee Mile	3.23
End Levee Mile	3.23
Location	Water Side
Category	Earthen Levee
Item	Vegetation
Levee mile 3.23, water side vegetation, looking up stream.	
cathom_f_20101019_161.jpg

4	3.23	3.23	Earthen Levee	Vegetation	WS	A	Control annual grass and weeds on the levee slopes and easements.	39.163589 ° -121.559494 °	39.163589 ° -121.559494 °	2 Y
5	3.24	3.24	Earthen Levee	Slope Stability	LS	A	Repair slope instability. Inspector Comments: This item was identified with an Unacceptable rating in the USACE PI report for the City of Marysville 1 Levee System (MRY1_2010_a_009). Reinspection on 12/9/10 verifies that repairs were made as indicated in the 11/22/10 letter from the City.	39.163589 ° -121.559494 °	39.163589 ° -121.559494 °	3 Y

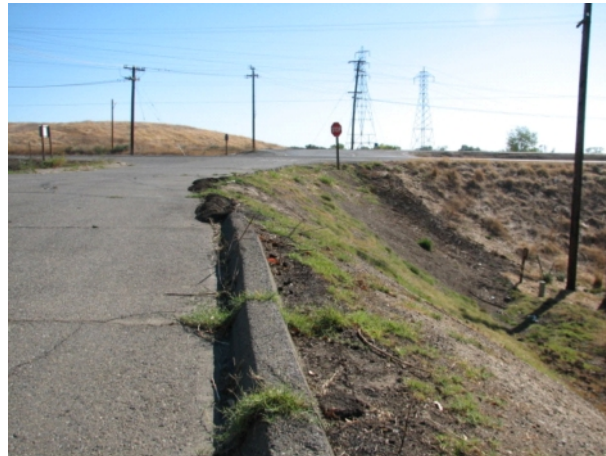
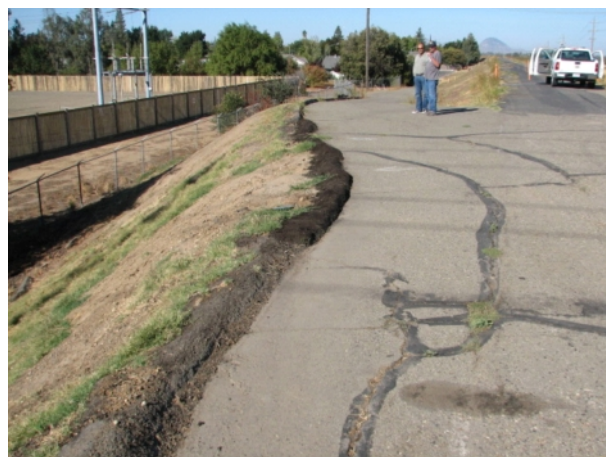
Levee Mile Report Line	5
Start Levee Mile	3.24
End Levee Mile	3.24
Location	Land Side
Category	Earthen Levee
Item	Slope Stability
This item was identified with an Unacceptable rating in the USACE PI report for the City of Marysville 1 Levee System (MRY1_2010_a_009). Reinspect on 12/9/10 verifies that repairs	
cathom_f_20101019_162.jpg

Levee Mile Report Line	5
Start Levee Mile	3.24
End Levee Mile	3.24
Location	Land Side
Category	Earthen Levee
Item	Slope Stability
This item was identified with an Unacceptable rating in the USACE PI report for the City of Marysville 1 Levee System (MRY1_2010_a_009). Reinspect on 12/9/10 verifies that repairs	
cathom_f_20101019_163.jpg

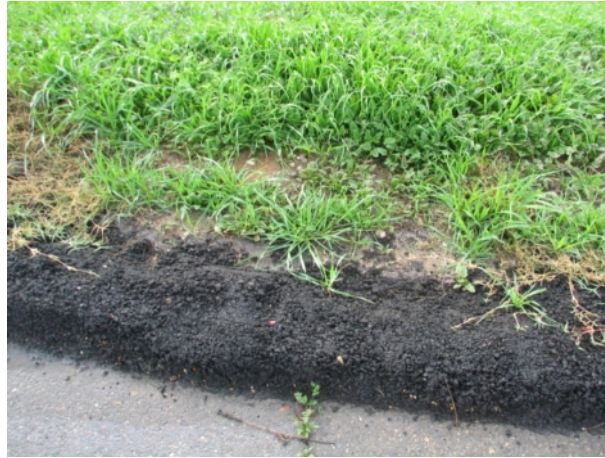
cathom\_f\_20101209\_164.jpg

Levee Mile Report Line	5
Start Levee Mile	3.24
End Levee Mile	3.24
Location	Land Side
Category	Earthen Levee
Item	Slope Stability

This item was identified with an Unacceptable rating in the USACE PI report for the City of Marysville 1 Levee System (MRY1\_2010\_a\_009). Reinspect on 12/9/10 verifies that repairs

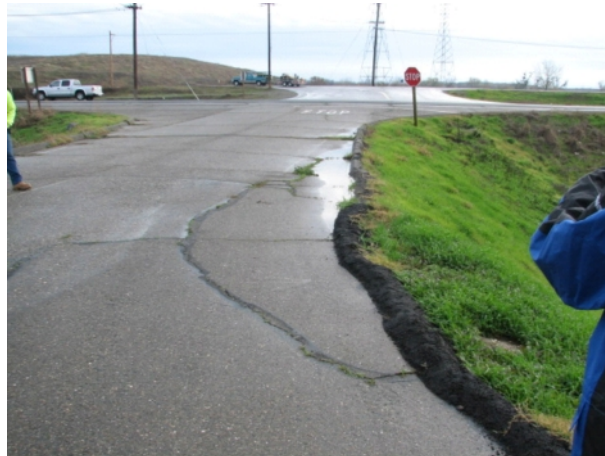
cathom\_f\_20101209\_165.jpg

Levee Mile Report Line	5
Start Levee Mile	3.24
End Levee Mile	3.24
Location	Land Side
Category	Earthen Levee
Item	Slope Stability

This item was identified with an Unacceptable rating in the USACE PI report for the City of Marysville 1 Levee System (MRY1\_2010\_a\_009). Reinspect on 12/9/10 verifies that repairs

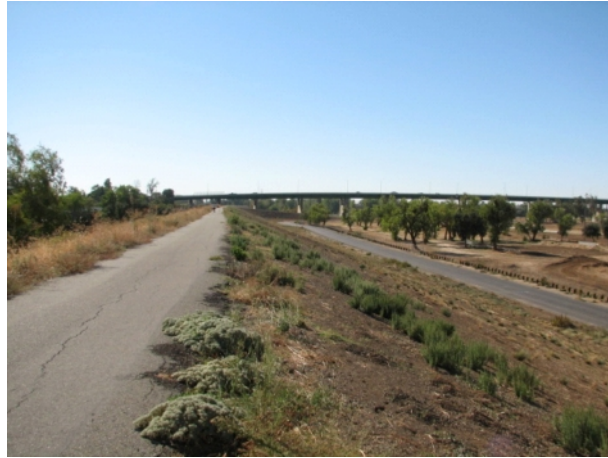
Levee Mile Report Line	1
Start Levee Mile	0.00
End Levee Mile	0.00
Location	Water Side
Category	Earthen Levee
Item	Vegetation
Levee mile 0.00, vegetation on water side slope.	
cathom_f_20101019_165.jpg

LMR No.	Levee Mile		Category	Item	* Location	** Rating	Action/Comment	GPS Latitude/Longitude		Issue No.
	Start	End						Start	End	Photo
1	0.00	0.00	Earthen Levee	Vegetation	WS	A	Control annual grass and weeds on the levee slopes and easements.	39.149371 ° -121.601100 °	39.149371 ° -121.601100 °	2 Y
2	0.02	0.45	Earthen Levee	Vegetation	LS	M	Control annual grass and weeds on the levee slopes and easements.	39.149371 ° -121.601098 °	39.143275 ° -121.600329 °	1 Y

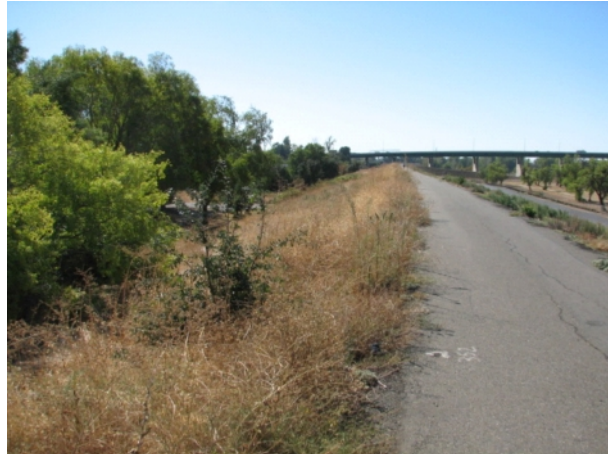
Levee Mile Report Line	2
Start Levee Mile	0.02
End Levee Mile	0.45
Location	Land Side
Category	Earthen Levee
Item	Vegetation
Levee mile 0.00, vegetation on land side slope.	
cathom_f_20101019_164.jpg

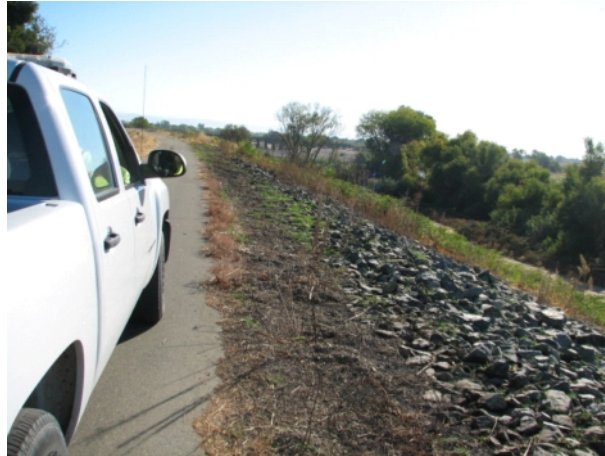
cathom\_f\_20101019\_168.jpg

Levee Mile Report Line	1
Start Levee Mile	0.34
End Levee Mile	0.34
Location	Water Side
Category	Earthen Levee
Item	Vegetation

Levee mile 0.34, water side slope.

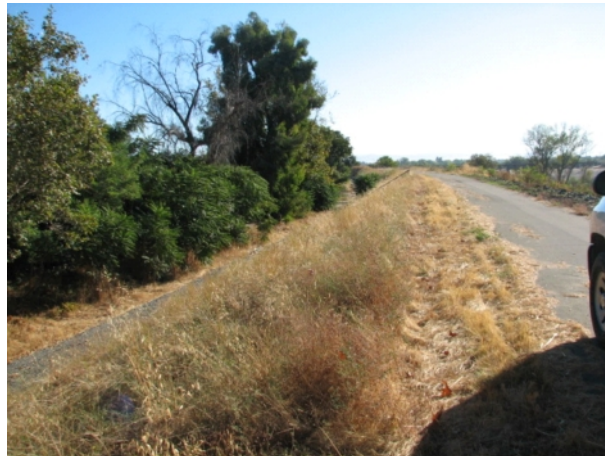
cathom\_f\_20101019\_167.jpg

Levee Mile Report Line	2
Start Levee Mile	0.34
End Levee Mile	1.00
Location	Land Side
Category	Earthen Levee
Item	Vegetation

Levee mile 0.34, vegetation looking up stream.

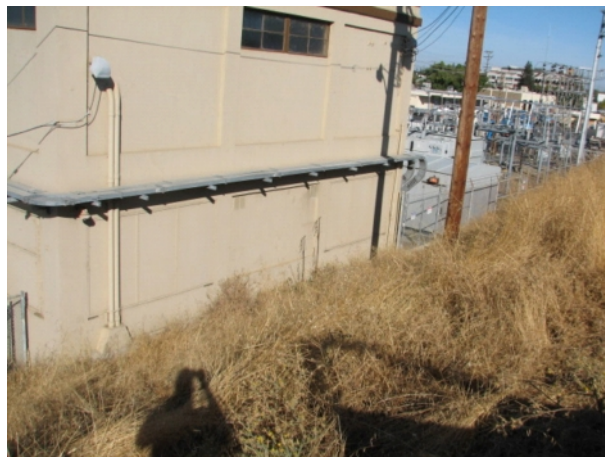
cathom\_f\_20101019\_166.jpg

Levee Mile Report Line	4
Start Levee Mile	0.86
End Levee Mile	0.86
Location	Land Side
Category	Earthen Levee
Item	Encroachments

Building encroaching at land side levee toe.

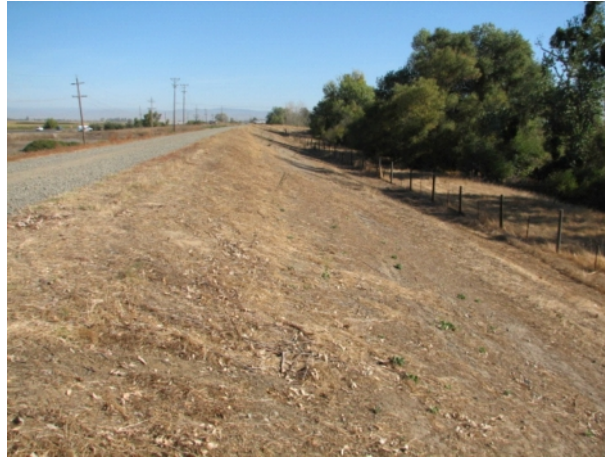
cathom\_f\_20101019\_169.jpg

Levee Mile Report Line	5
Start Levee Mile	4.36
End Levee Mile	4.36
Location	Water Side
Category	Earthen Levee
Item	Vegetation

Water side vegetation removed. Levee mile 4.36.

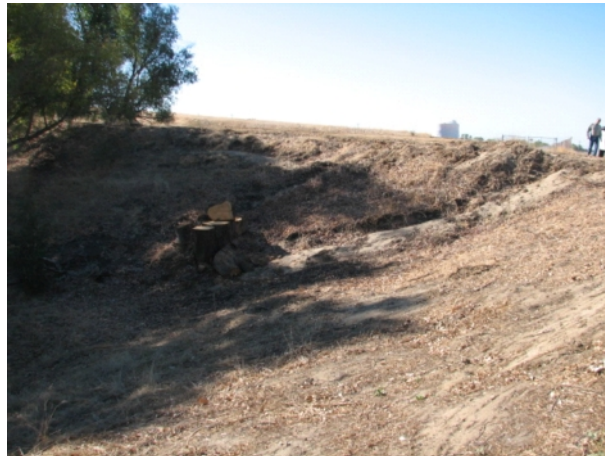
cathom\_f\_20101019\_170.jpg

Levee Mile Report Line	5
Start Levee Mile	4.36
End Levee Mile	4.36
Location	Water Side
Category	Earthen Levee
Item	Vegetation

Levee mile 4.36, water side tree removed as part of vegetation removal.

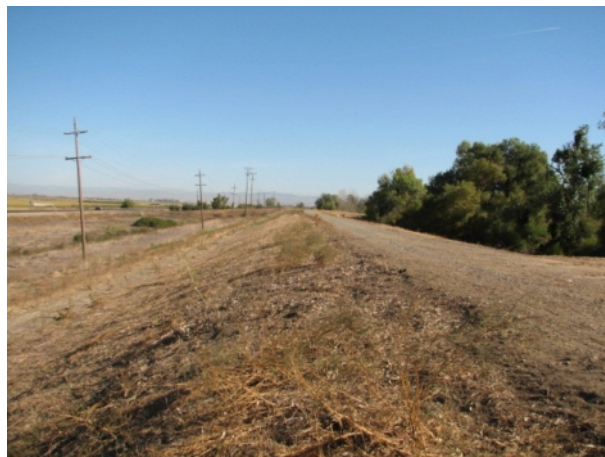
cathom\_f\_20101019\_171.jpg

Levee Mile Report Line	6
Start Levee Mile	4.36
End Levee Mile	4.36
Location	Land Side
Category	Earthen Levee
Item	Vegetation

Levee mile 4.36, land side levee slope vegetation removed. Looking up stream.

6	4.36	4.36	Earthen Levee	Vegetation	LS	A	Control annual grass and weeds on the levee slopes and easements. Inspector Comments: This is the unacceptable items from the Corps.	39.178863 ° -121.545445 °	39.178863 ° -121.545445 °	7 Y
7	4.90	4.90	Earthen Levee	Vegetation	CR	A	Control annual grass and weeds on the levee slopes and easements.	39.185389 ° -121.539973 °	39.185389 ° -121.539973 °	8 Y

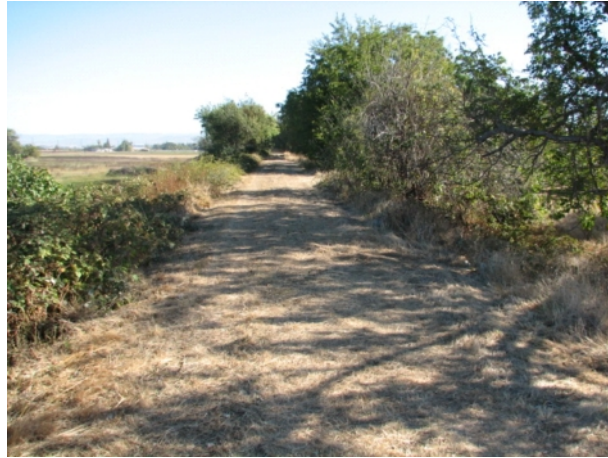
Levee Mile Report Line	7
Start Levee Mile	4.90
End Levee Mile	4.90
Location	Crown
Category	Earthen Levee
Item	Vegetation
Levee mile 4.90, this is the patrol road.	
cathom_f_20101019_172.jpg
